DETERIORATION OF GNEISS DUE TO LIMEWASH
AT EASTERN STATE PENITENTIARY

Elizabeth Lael Anthony Johansen

A THESIS

Historic Preservation

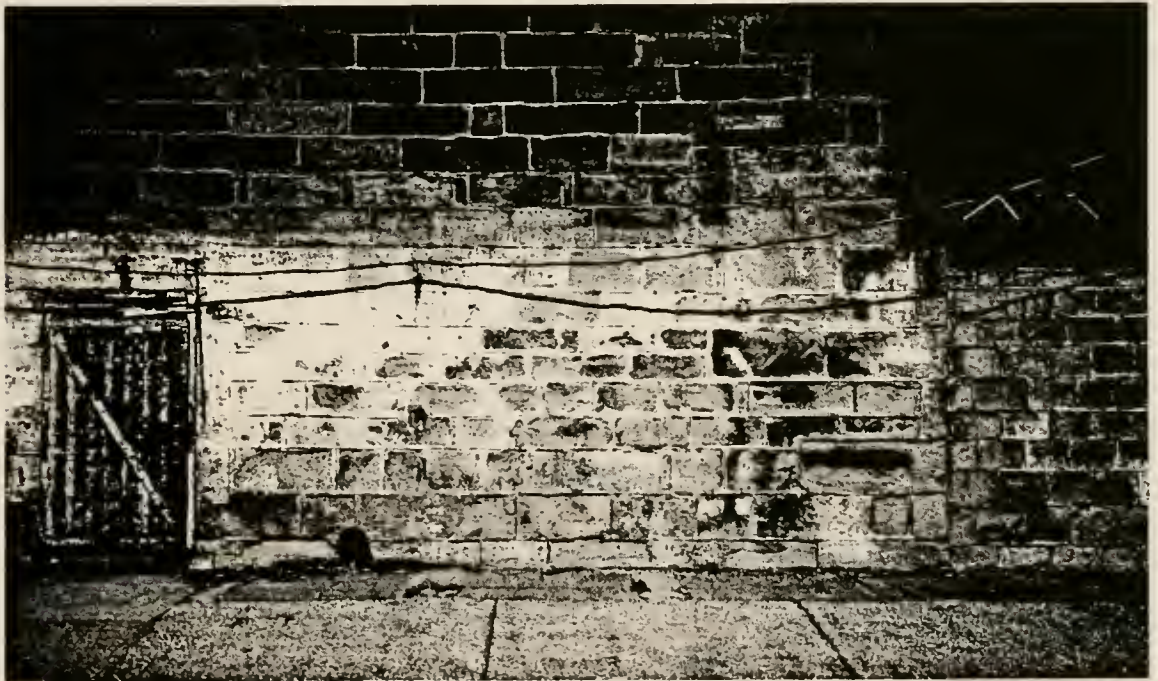
Figure 4: Differential Deterioration

Note the relative soundness of the upper material and the deterioration of the lower area.

This thesis will investigate the mechanisms contributing to the differentially aggressive deterioration of the limewashed areas of this wall. Through tests of deteriorated material and sound samples, this investigation will attempt to determine the relative contributions of the limewash itself and environmental pollution to the observed deterioration.

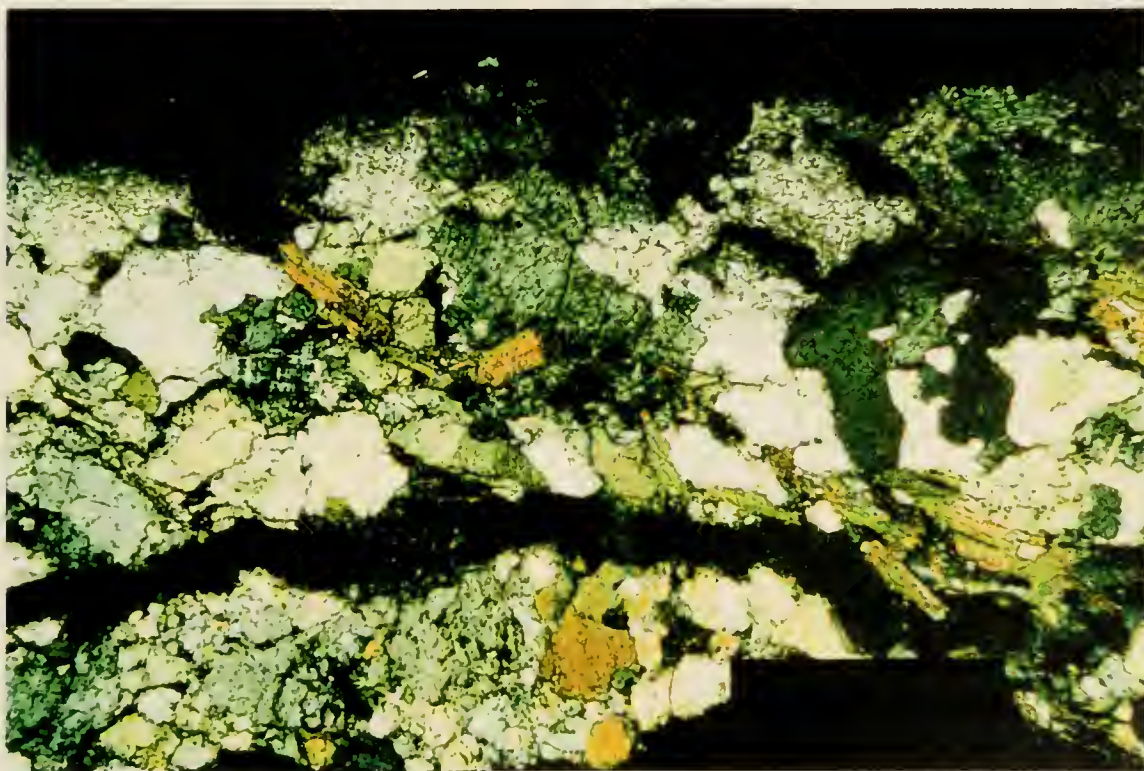
Figure 11: Sample 1

Deteriorated Crust, No Limewash

Polarized light photomicrograph under crossed nicols at 25x magnification
Photo: G.I. Omar

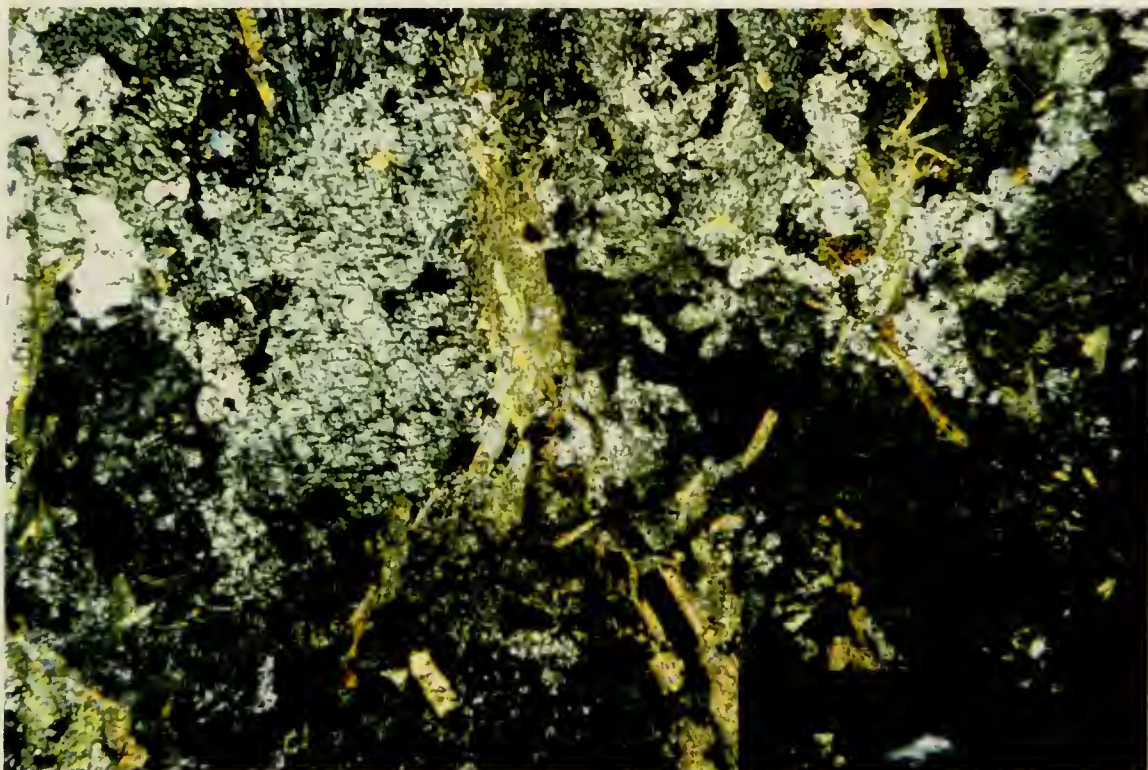
Figure 23: Sample G, Lime Soak

Polarized light photomicrograph under crossed nicols at 25x magnification
Photo: G.I. Omar
